# **Great Bay Nitrogen Nonpoint Source Study Implementation Phase I - Sagamore-Hampton Golf Club BMPs**

A Final Report to  
The New Hampshire Department of Environmental Services

Alyson Eberhardt

21 December 2016

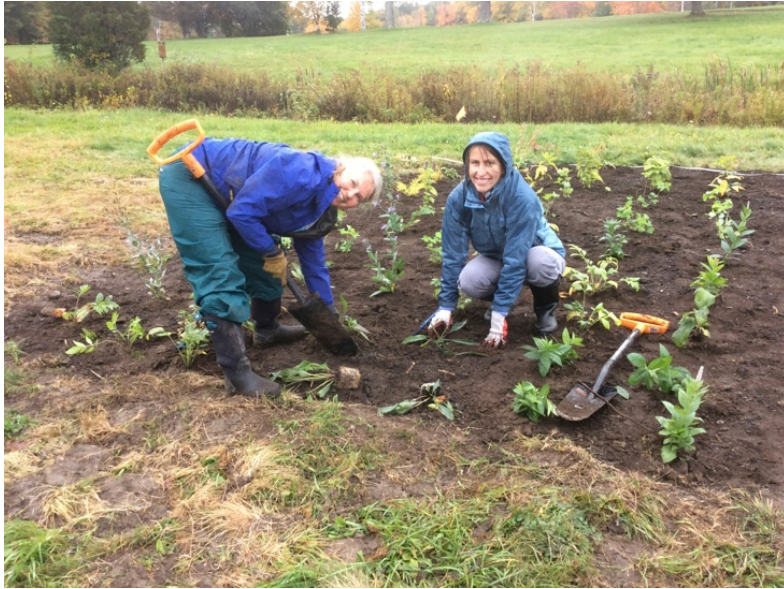
Coastal Research Volunteers plant a buffer of over 500 native perennial wildflowers adjacent to the pond near the 14<sup>th</sup> hole.

A pollinator meadow was designed for the area along the pond that discharges into Cornelius Brook near the 14th hole. Native flowering perennials were used to restore the buffer with the dual goals of mitigating stormwater impacts of nutrients and sediment to the pond and brook as well as providing habitat for native pollinators. Dr. Neal donated the plants to the project. A list of species planted and quantities is provided in Table 1. Sagamore prepared the beds by turning over the top turf and soil and adding 6 inches of compost to each planting plot.

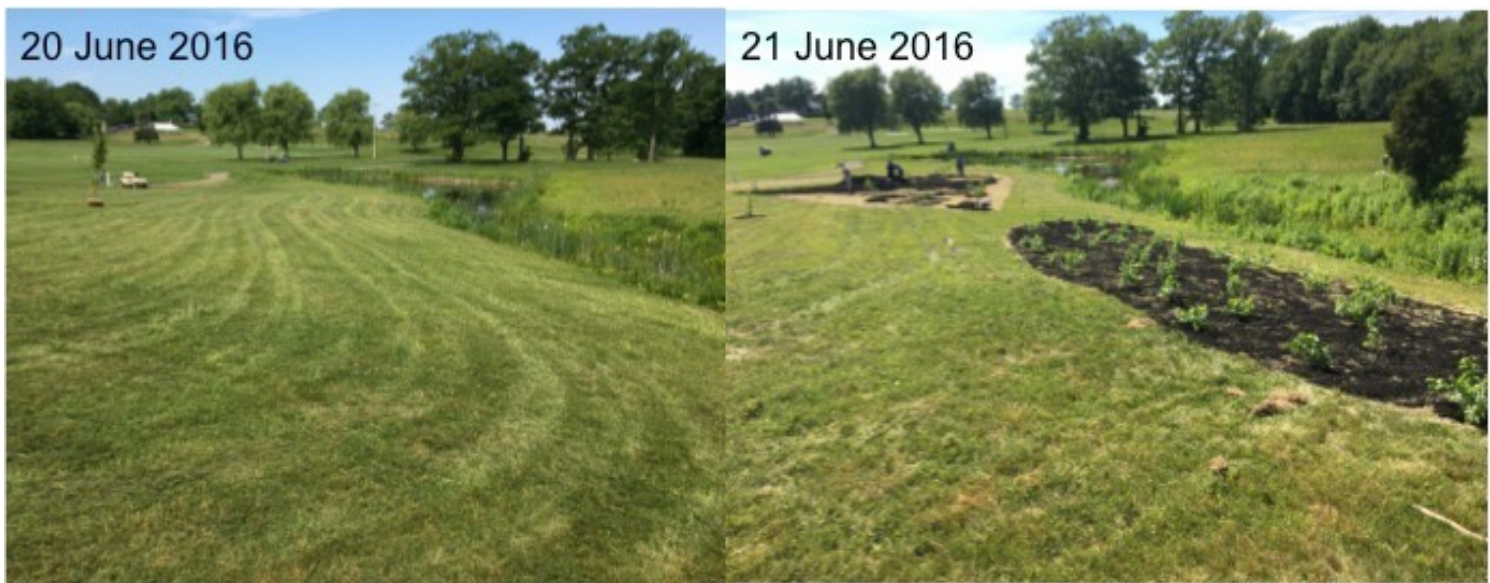
View of site 2 prior to planting trees and shrubs (20 June 2016) and after planting trees and shrubs (21 June 2016)

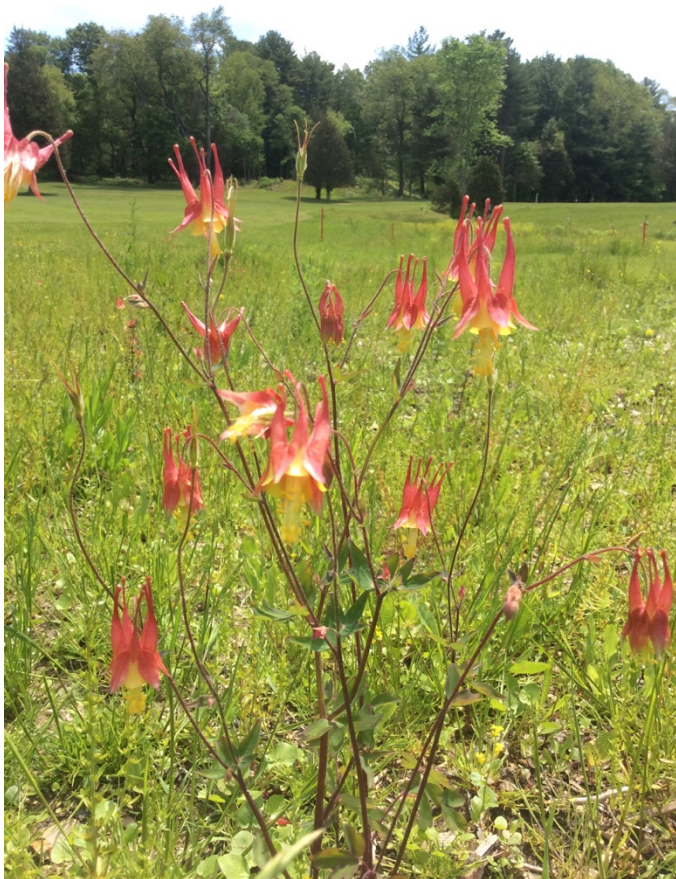
Columbine (*Aguilegia canadensis*) flowering in the pollinator meadow one year after planting.

Photomonitoring stations were established at each planting plot on the day of planting. Pictures were captured at each site visit to document growth and survival over time. Example pictures are provided in the Photographic Documentation section. Monitoring observations suggest a survival rate of 85% at two of the pollinator plots and 45% at the westernmost plot subject to the wettest soil conditions. Seeding efforts were successful based on observations of *Rudbeckia* and *Elymus* throughout the three pollinator beds in 2016. Native perennials can take 2-3 years to establish and outcompete species pre-existing in the soil seed bank so the observed success so soon after planting and seeding is promising. At the close of the project, survival of shrub and tree species was 100%

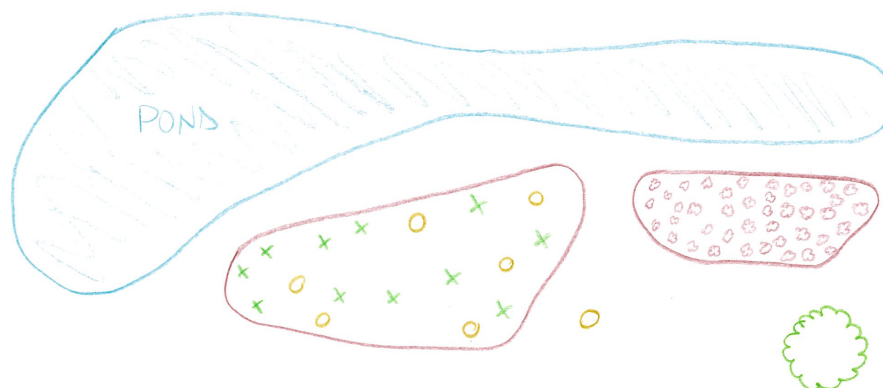
AREA 2

SWAMP WHITE OAK - *QUERCUS BICOLOR*
-

RIVER BIRCH - *BETULA NIGRA*
-

SWEET PEPPERBUSH - *CESTRUM ALNIFOLIA*
-

GRO-LOW SUMAC - *RHUS AROMATICA* "GRO LOW" (N=50)

Working with Cathy Neal, PhD., landscape horticulturist for UNH Cooperative Extension, planting plans was developed for the restoration areas (Appendix 1).
