NH Volunteer Beach Profiling Report 2020

North Hampton State Beach, NH

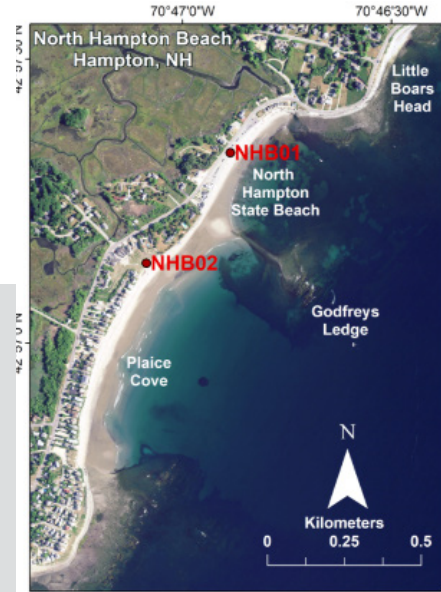
Max and min average elevation

The figure above shows beach elevation profiles that extend from the seawall to the low tide line at profiling station NHB01.

The February 2018 (red) profile depicts pre-storm beach conditions. The March 2018 profiles (black and blue) show the impact of the 2018 nor'easters. Note the erosion of the lower beach contrasted by the increase in elevation at the seawall in the post-storm profiles. This increase in elevation at the seawall in March is due to the formation of the gravel ramp mentioned above from sediment being pushed landward by the waves. Once formed, the ramp allows pebbles and cobbles to overtop the seawall causing additional damage to the infrastructure.

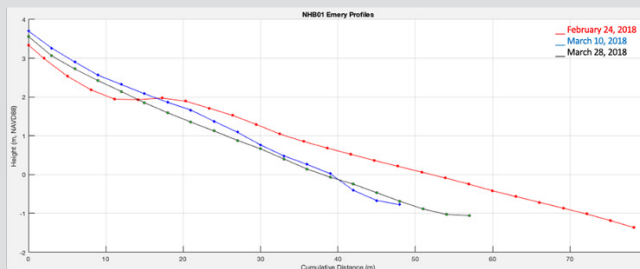
Changes in sand volume at NB01

Each blue line represents the estimated volume of sediment measured along a 1-meter-wide swath of the beach for each given date at NHB01. A series of storms in Mar 2018 caused major erosion. The beach recovered for a period of ~7 months but a second cycle of erosion occurred in Dec 2018 and Jan 2019 due to winter storms. This erosional cycle left the beach at some of the lowest volumes recorded during the study period at NHB01. The beach regained volume quickly following these storms and reached its maximum volume in Aug 2019. The beach reached its minimum volume in Jan 2020 (likely due to two strong storms in Dec 2019), but again recovered quickly. When sediment volume is lower, the coast is more vulnerable to storm impacts such as flooding and overwash. High volumes of sediment on the beach can help combat storm damages, but in Mar 2018 high volumes of sediment were pushed against the base of the seawall resulting in overwash and damage to infrastructure.
