NH Volunteer Beach Profiling Report 2020

Jenness Beach, Rye, NH

Jenness Beach 01

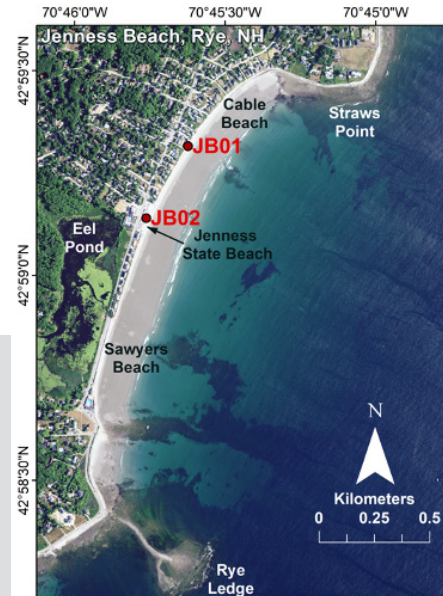
Max and min average elevation

The figure above shows three profiles that extend from the seawall to the low tide line at station JB01. The Sept 1, 2019 profile (red) shows the beach at its maximum mean elevation and sand volume measured during the study period. In contrast, the Apr 2018 profile was measured following severe late winter nor'easters that eroded the beach. The mid beach is ~0.8m lower and the lower beach is ~0.5m lower in elevation in comparison to the Sept 2019 profile. The Dec 29, 2018 profile was also measured after a period of erosion and had a very low mean elevation and volume but showed a different shape; sand was moved from the lower beach and transported to the upper beach, forming a berm. JB01 is among the beaches with the lowest minimum average elevations and volumes recorded during the study period rendering it highly vulnerable to storms.

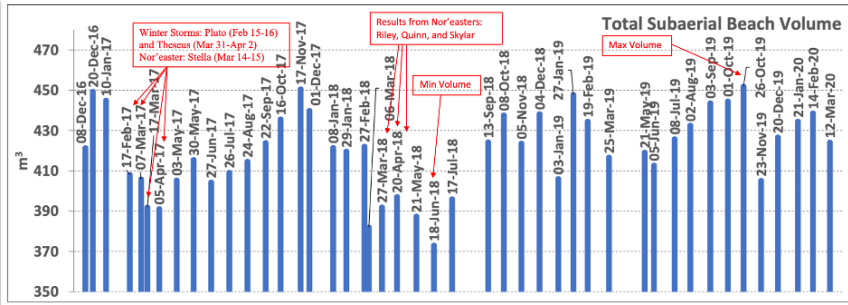
Changes in sand volume at JB02

The 2017 winter storms significantly eroded the beach at profiling station JB02 shown by the loss of volume from Feb to Apr. From late spring through fall 2017, JB02 regained sediment volume to pre-winter levels. More severe storm activity in winter 2018 than in 2017 resulted in the worst erosional period of the study. Three nor'easters in March 2018 were particularly hard on Jenness Beach because there was no recovery time between storms. From Mar to Jul 2018, the beach struggled to regain sediment volume. The beach began recovering in Jul 2018 and fluctuated until 2019. In winter 2019, several minor storms impacted JB02 and the sediment volume at JB02 declined, but the impacts were minimal compared to previous winters.

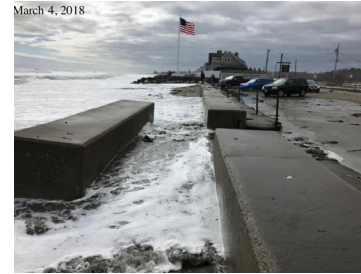
Jenness State Beach's low elevation leaves it susceptible to flooding and storm surge. This photo from Mar 4, 2018 shows waves striking the seawall at high tide following Nor'easter Riley.

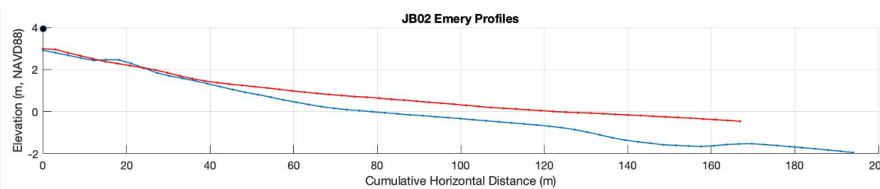
Max and min average elevation

JB02 lacks large morphologic features and has a low elevation and is therefore very vulnerable to storm related erosion and flooding. Despite its lack of major accretional features, JB02 can show large changes in elevation. The maximum average beach elevation occurred on Oct 26, 2019 (red above). The minimum elevation profile occurred in Jun 2018 (blue) after a series of three late winter nor'easters. The lower beach was over one meter lower in elevation and the mid beach was over half a meter lower than in Oct 2019. The observed changes in elevation are very significant given the overall low elevation of Jenness Beach.
