NH Volunteer Beach Profiling Report 2020

📍 Seabrook Beach, NH

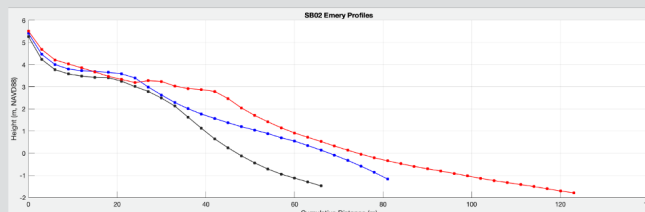
Max and min average elevation

The lowest beach elevations measured during this study occurred on May 18, 2018 (black) as a result of severe March nor'easters. The profile recorded

on September 10, 2018 (blue) shows a significant increase in beach elevation due to accretion during summer. The maximum elevation for the study period occurred in August 2019 (red) and shows the differences in shape the beach can have between erosional and accretional conditions.

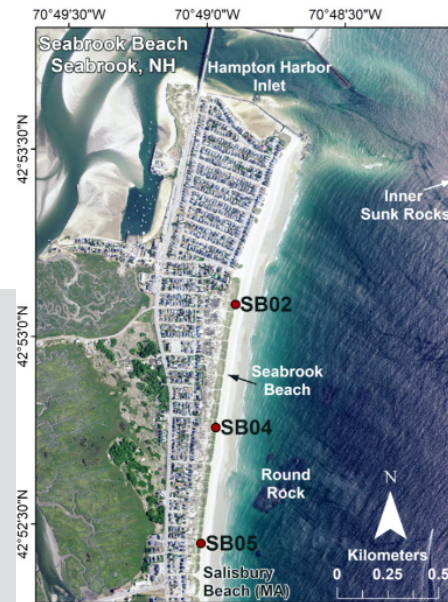
Changes in sand volume at SB02

SB02 underwent two cycles of erosion and accretion (rebuilding) over the study period. The first major erosional period came with the late winter 2018 nor'easters which removed a large volume of sediment. These erosional events were followed by a recovery period from June- September 2018. The second erosional period was less severe than the first occurring in early spring 2019. During this period, the beach lost very little volume and elevation. Consequently, the beach was able to build during the summer and reached the maximum volume recorded during the study period in August 2019. In contrast to the other stations at Seabrook Beach, SB02 maintained volume throughout the fall of 2019. This is likely due to the beach nourishment that occurred at this location in November 2019.

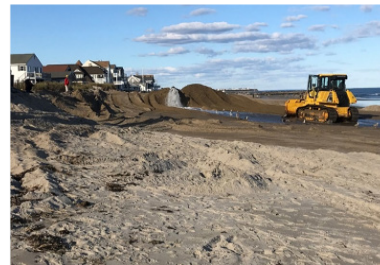
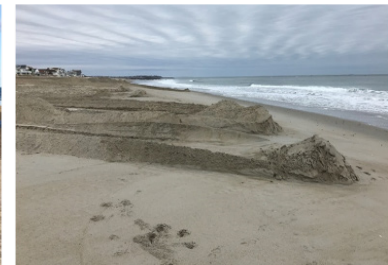
Sand being pumped on the beach north of SB02 on Oct 16, 2019 (left). The sand is immediately spread by bulldozers (right) and over time by natural processes.

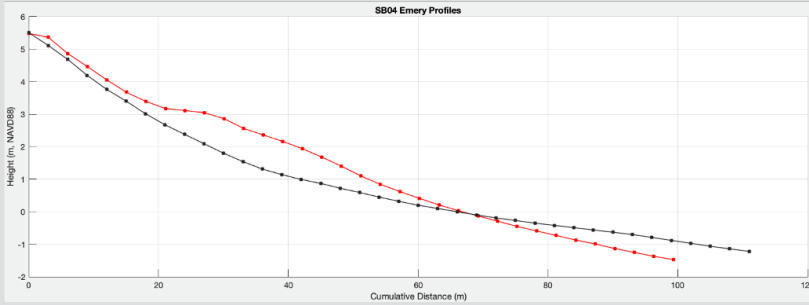
Max and min average elevation

When comparing the maximum (August 3, 2019) and minimum (November 25, 2019) beach elevation profiles for station SB04, there is very little difference in the upper profile (~0.3 m), but the mid beach is ~1.0 m lower. Interestingly, it appears that between August and November, sand was eroded from the upper and mid beach and transported and deposited on the lower beach.

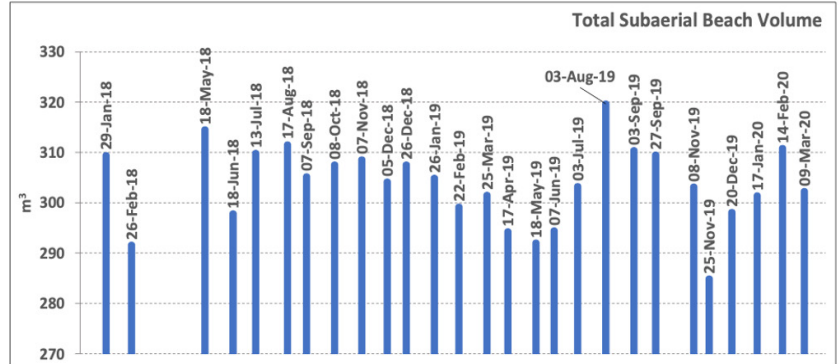
Changes in sand volume at SB04

The beach went through multiple periods of erosion and accretion during the study period. The initial sand volume (January 2018) indicates the beach was in a recovery (accretional) phase. However, the beach was eroded by winter storms and high waves in February 2018. A gap exists in the database during March and April 2018 and the effects of the severe late winter nor'easters were not measured. The beach appears to have recovered from the winter storms by mid summer and maintained sediment volumes for the remainder of 2018.

The second period of erosion occurred in winter and spring 2019. The beach recovered from this erosional cycle and reached a maximum volume on August 3, 2019. Fall storms caused a short erosional period, during which the minimum volume was recorded in November 2019. However, the impact of the severe nor'easters in March 2018 were not measured, but likely had a lower volume. The beach steadily increased in volume through February 2020.

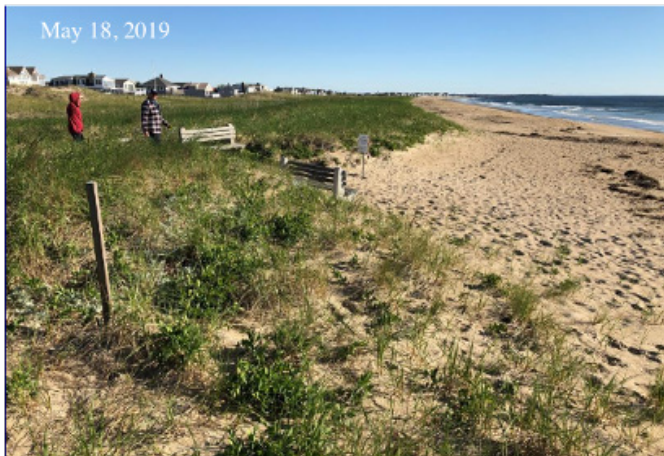
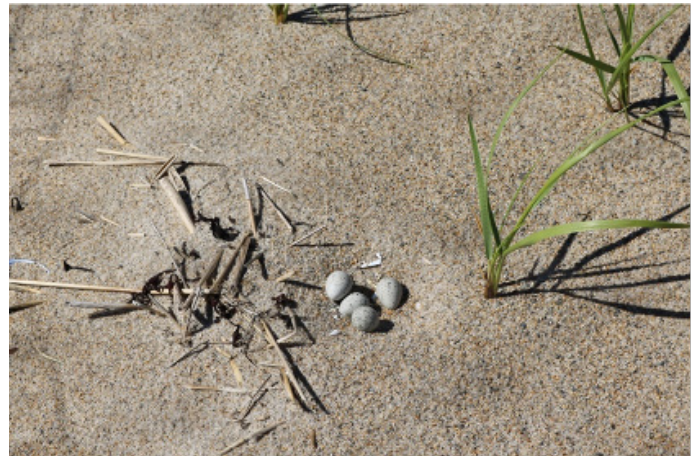
Images of Seabrook Beach dune system at SB04. The photograph on the left taken on May 18, 2019 shows the ability of dune grasses to trap sand. Dune grasses provide stability for large volumes of sand with the baffling effect of the above ground vegetation and stabilize the sand with the roots. During storms, waves erode sand from the dunes and intertidal beach system and carry it towards the ocean. The sand is deposited in the nearshore forming a bar which effectively weakens wave energy. Following the storm, waves slowly bring the sand back up to the beach allowing it to recover in calm weather conditions. The dune system also begins to recover by accumulating sand by aeolian processes (wind moving sand and shaping the dunes). Dune systems are coupled with beaches and are integral for the optimal functionality of beach ecosystems. Dunes provide natural storm protection and can help protect our coastal infrastructure. Finally, dunes are valuable habitats and provide protection and homes for several species. The photograph on the right taken on June 6, 2019 shows a piping plover (*Charadrius melodus*) nest with four eggs on Seabrook Beach near SB04.

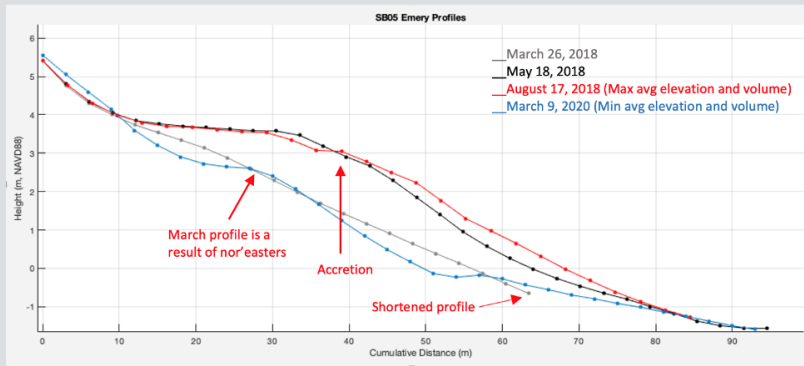
Max and min average elevation

The maximum and minimum profiles depict erosional and accretional trends in beach elevation. The beach was severely eroded in March 2018, but by May 2018 it had recovered. However, in Mar 2020 the beach had once again eroded. Subsequently, the beach recovered, repeating the erosion to accretion cycle.

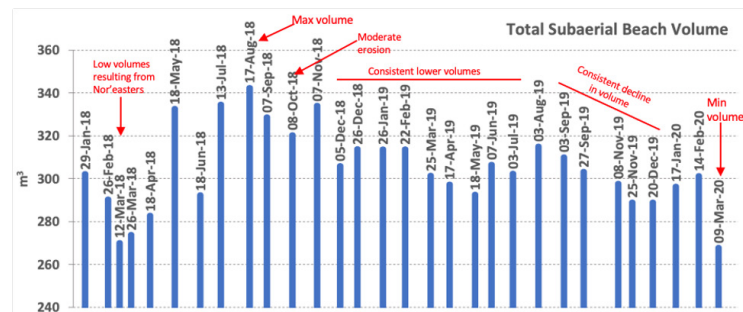
Changes in sand volume

In early 2018, station SB05 was

in an erosional state due to several winter storms. Following the Mar 2018 nor'easters, the profiles were short and some of the lowest volumes were recorded that year. The beach began to recover in Apr and by May 18, 2018 SB05 had gained a large volume of sand back. The beach maintained sand volume from May through summer 2018 apart from the Jun 18 observations. Moderate erosion occurred in September and Oct 2018. Nor'easters and winter storms led to consistently lower sand volumes throughout late 2018 and early 2019. The beach did not recover during the later months of 2019 as more storms in Oct led to more erosional events and decreased sand volumes. Mar 9, 2020 marked severe erosion with the lowest volume recorded in the study. Some erosion occurred at other stations in Mar 2020, but SB05 was the only station that reached its minimum volume and elevation for the study period during this month.
