NH Volunteer Beach Profiling Report 2020

Hampton Beach, Hampton, NH

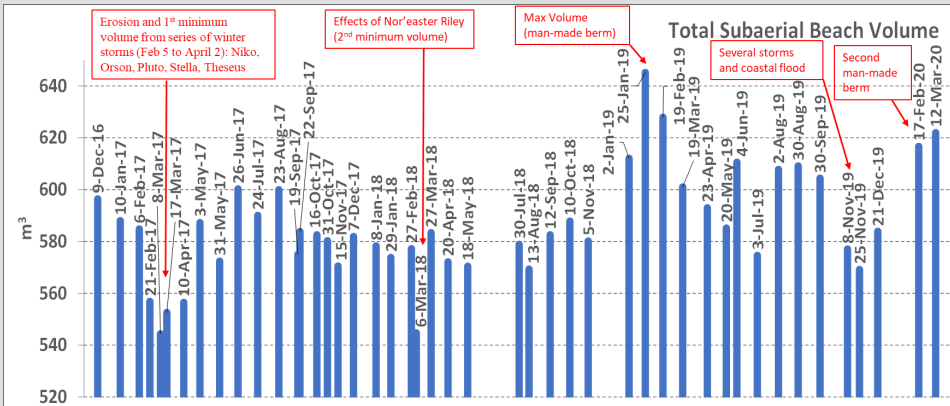
Storm effects and recovery

In the figure to the left, each blue column represents the estimated volume of sand above approximately mean low water along a 1-meter-wide swath of beach elevation profile for each measurement date. Major fluctuations

in volume at HB02 were primarily related to storms. A series of winter storms in Feb and Mar 2017 caused significant erosion; beach recovery occurred in the following spring. Similarly, a series of severe nor'easters in March 2018 caused major erosion of the beach, with moderate recovery through the spring and summer. However, in winter 2019, the beach increased in elevation and volume. Several storms in fall 2019 also caused erosion, but the beach once again recovered late winter and early spring. During the study period, Hampton Beach was significantly eroded by winter storms, but tended to recover in spring and summer. However, this is a general trend and erosion or accretion can occur in any season as seen in winter 2019.

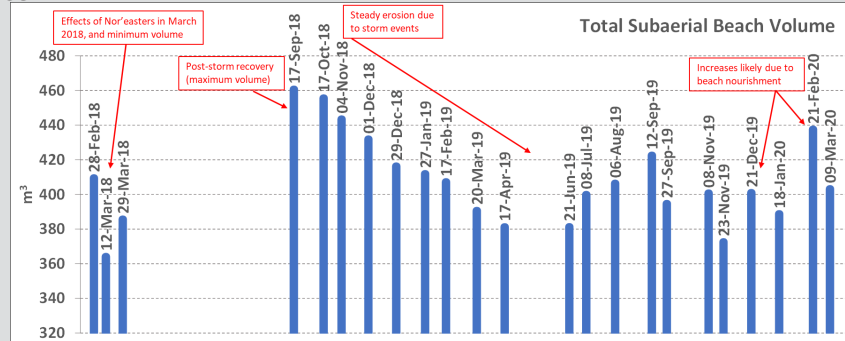
Changes in sand volume at NB02

A series of nor'easters in Mar 2018 caused significant erosion along the length of an already low and flat beach. Evidence of initial recovery could be seen in the profile taken in late Mar, but due to a gap in the data record between Apr and Sep, the timing of recovery is unknown. By mid-Sep, the beach had regained a lot of the sediment volume lost during the Mar storms. A very consistent decline in volume followed, with storms and nor'easters causing continuous erosion through summer 2019. Several periods of erosion and accretion occurred in the rest of 2019 and into early 2020, but the beach at HB04 never regained the volume seen in fall 2018 during this study. In Nov 2019, the beach just south of HB04 was nourished with sand dredged from Hampton-Seabrook Harbor (approx. 32,000 yds³). An increase in volume was seen in the Dec 2019 and Feb 2020 profiles, likely a result of the nourishment, but the volumes decreased once again in Mar.
